THERMOGRAPHIC ANALYSIS OF COMPOSITE COBONDS ON THE X-33

ABSTRACT

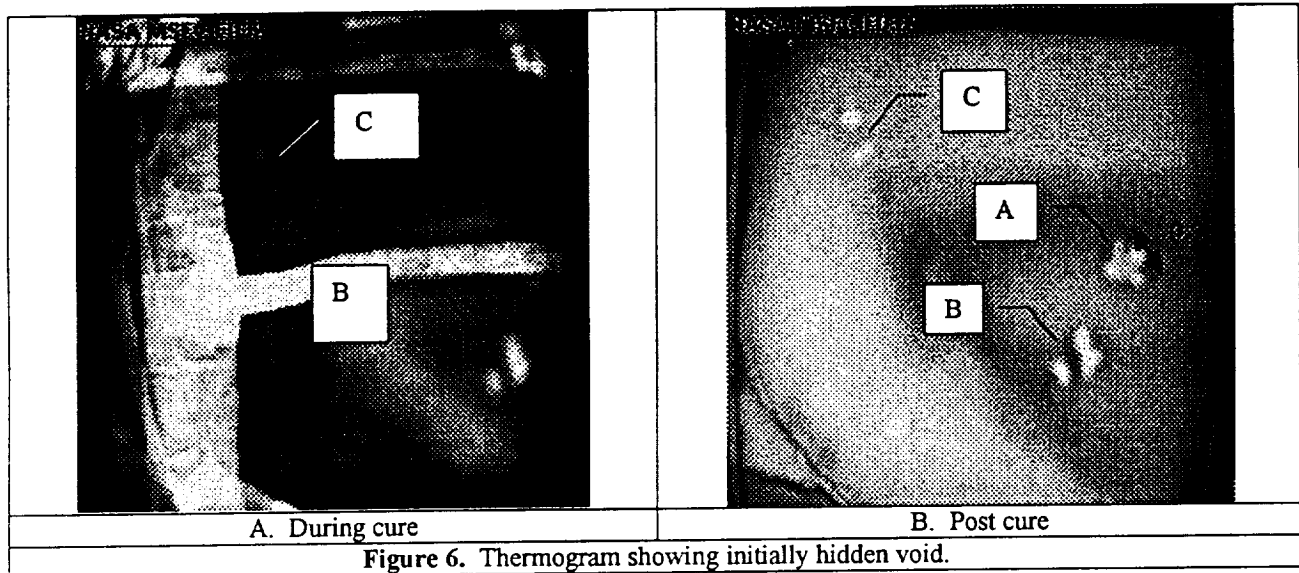
As previously described, the initial inspections were performed when the caps were still under the vacuum bag. In this manner, voids or air pockets, trapped under the cap could be eliminated before the cure was complete or if the void was less than a previously determined critical size it could be accepted. Figure 6 demonstrates a thermogram of a cap section with two small, but acceptable, voids. When the part was cured and the bag removed a second inspection was performed (Figure 6b) revealing the first two known defects (B and C) as well as one that was hidden (A) beneath the breather ply strip.

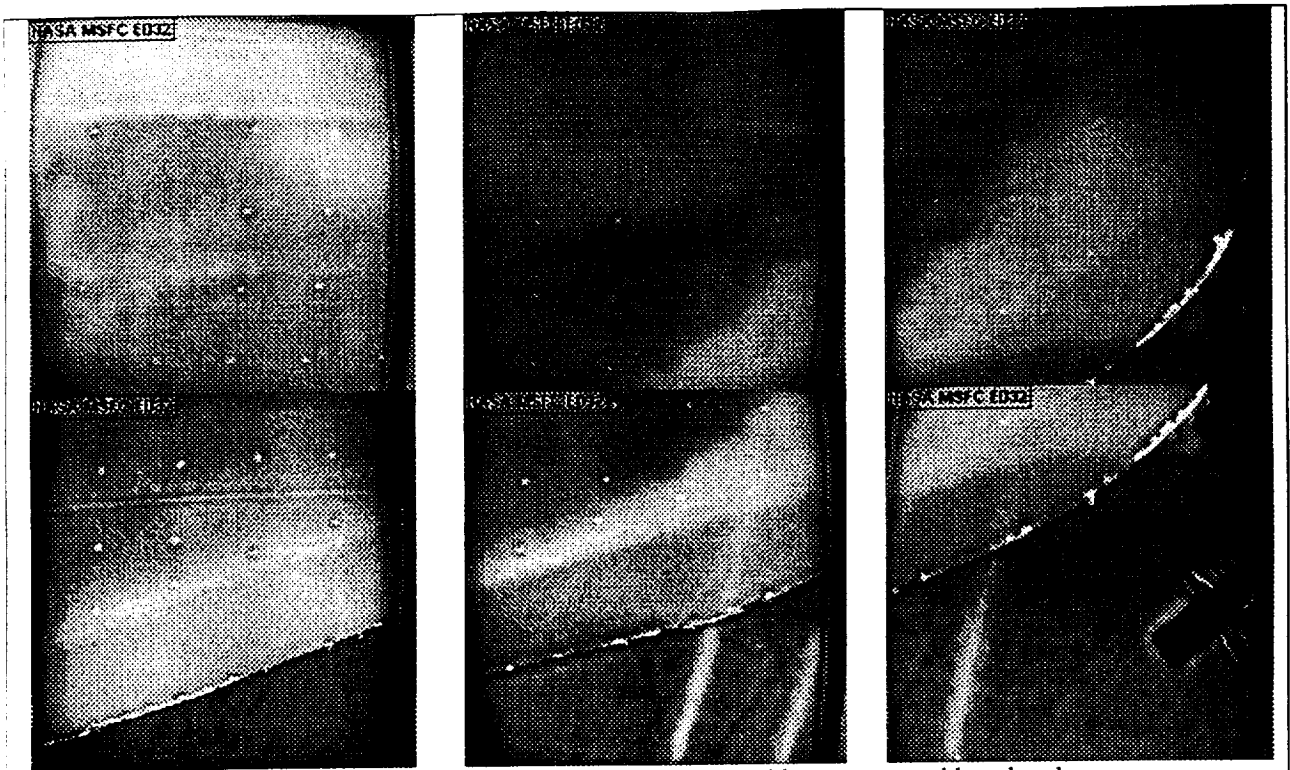
Figure 7. Sector inspections of a reinforcing cap with no unacceptable unbonds.

On average it took six image sequences to fully cover each cap. The results of thermography inspection of a reinforcing cap which did not reveal any unacceptable unbonds are shown in Figure 7. The images shown here were obtained after the bond line had cured and the vacuum bag had been removed. Minor temperature variations exist due to differences in the thickness of a foam filler material beneath the cap. A grid of hot points is visible where vent ports were drilled in the reinforcing cap to prevent the entrapment of air between the foam and the cap.

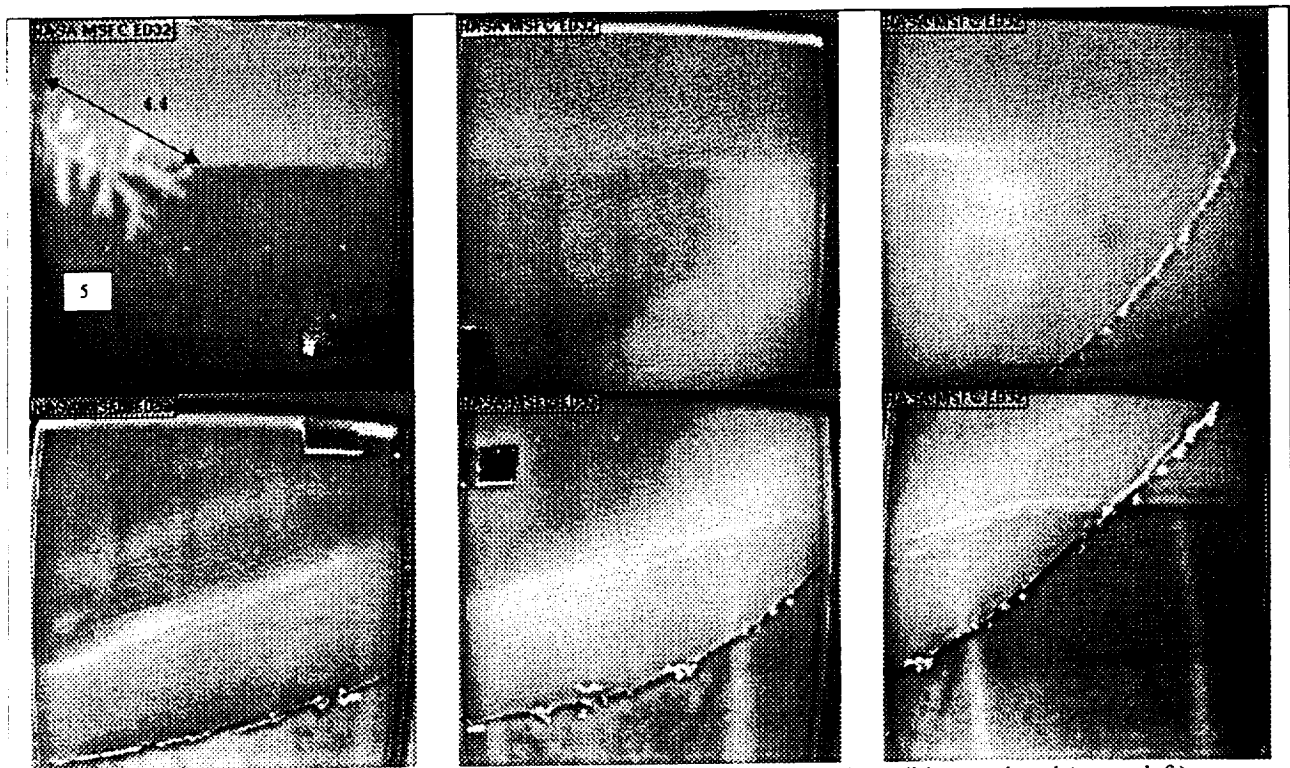
Figure 8. Sector inspections of a reinforcing cap with an unacceptable 4.4" long unbond (upper left).

The results of thermography inspection of a reinforcing cap which revealed an unacceptable unbond are shown in Figure 8. Again, these images were obtained after the vacuum bag had been removed. A branching unbond is visible in the upper left sector with a maximum length of approximately 4.4 inches. The unbond was just barely visible in the thermograms taken before the vacuum bag was removed being all but totally obscured by breather tubes and cloth that was placed around the outer edge of the panel.

Since this defect was unacceptably large an action was taken to try to fill the void with epoxy. To aid in the repair process lead foil tape markers were placed on the cap identifying the exact location of each leg of the void and verified by re-inspecting the region. Holes were then drilled in the reinforcing cap over the void and injected with epoxy to fill it. Thermograms were taken at various stages in this process are shown in Figure 9. After the third injection of epoxy, the size of the void had been diminished sufficiently that it was deemed acceptable.
